**West Campus Point
Homeowners Association**
December 3, 2011

STONEMARK
CONSTRUCTION MANAGEMENT

WCP History

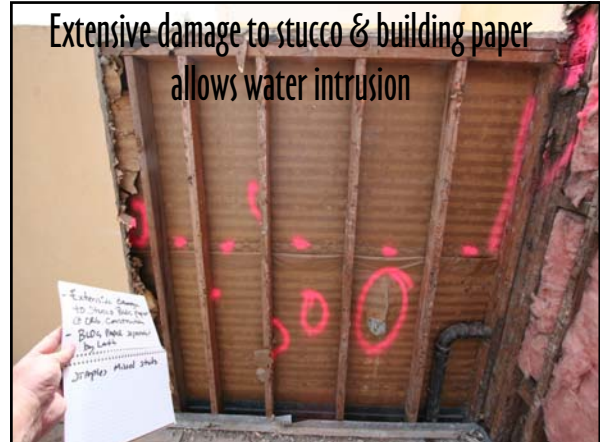
Extensive damage to stucco & building paper allows water intrusion

- Cut stucco for flashing installation
- Chase water damage to tie into good building paper
- Remove/ replace vents as required
- Power-wash building exteriors
- Install stucco waterproofing product – Sto Flexyl
- Seal penetrations, door and window frames

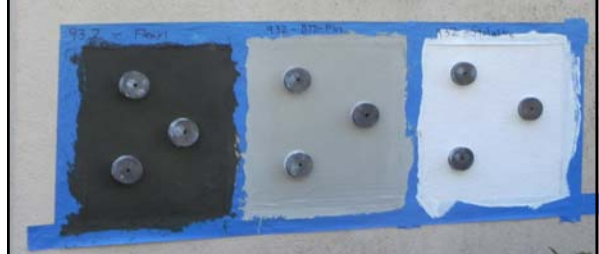
Sto Flexyl system was tested on site

- 1) power washing only- no sand-blasting required
- 2) directly over existing stucco, sealed at penetrations

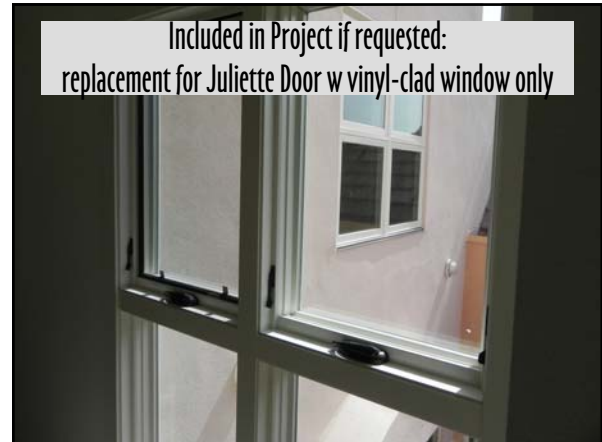
Included in Project:
2nd floor deck doors will be replaced with vinyl-clad

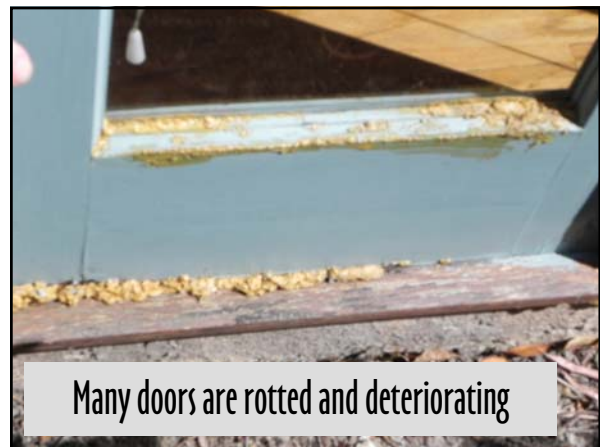
- Significant sources of water intrusion
- Many are rotted and deteriorating
- CC&Rs state they are homeowners' responsibility

Many doors are rotted and deteriorating

- For a complete job, the removal of all doors & windows is necessary to waterproof the openings
- This is an **IDEAL** opportunity to replace yours at a reduced cost
- We will coordinate with you as part of the project

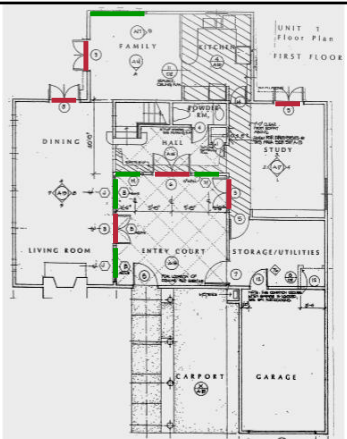
Window & Door Replacement Options:
Current operable doors: —
Current fixed doors: —

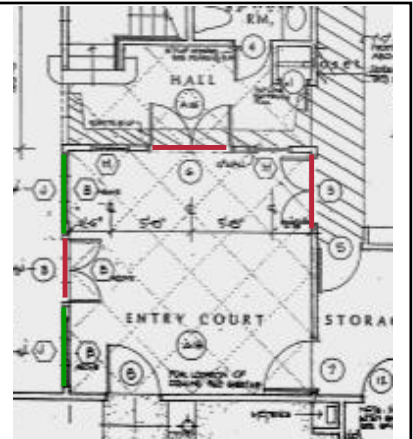
Current fixed doors w option to be converted to windows: —
